**DEPARTMENT OF TRANSPORTATION**

Contract #: 04-0120F4Cty: SF/ALA Rte: 80 PM: 13.2/13.9File #: 69.28**WELDING INSPECTION REPORT****Resident Engineer:**Pursell, Gary**Address:** 333 Burma Road**City:** Oakland, CA 94607**Report No:** WIR-014154**Date Inspected:** 10-May-2010**Project Name:** SAS Superstructure**OSM Arrival Time:** 700**Prime Contractor:** American Bridge/Fluor Enterprises, a JV**OSM Departure Time:** 1900**Contractor:** Zhenhua Port Machinery Company, Ltd (ZPMC), Changxing Island **Location:** Shanghai, China**CWI Name:** Zhao Chen Sun**CWI Present:** Yes No**Inspected CWI report:** Yes No N/A**Rod Oven in Use:** Yes No N/A**Electrode to specification:** Yes No N/A**Weld Procedures Followed:** Yes No N/A**Qualified Welders:** Yes No N/A**Verified Joint Fit-up:** Yes No N/A**Approved Drawings:** Yes No N/A**Approved WPS:** Yes No N/A**Delayed / Cancelled:** Yes No N/A**Bridge No:** 34-0006**Component:** Tower Components**Summary of Items Observed:**

**TOWER TRIAL ASSEMBLY**

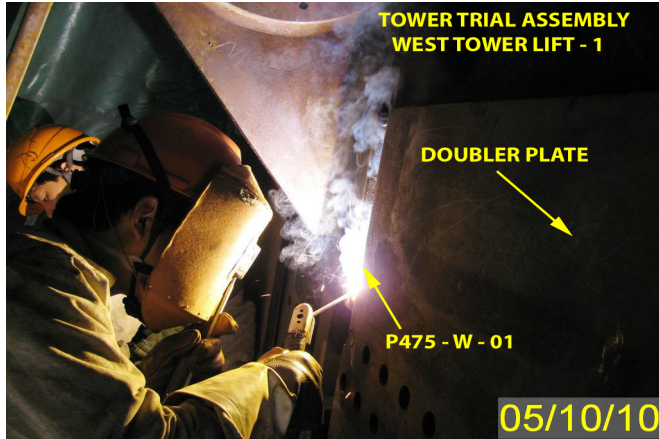
Weld joint # 01 located on West Tower Lift – 1 Skin ‘A’ doubler plate P475 - W. Welder is identified as 202100. ZPMC Quality Control (QC) Inspector is identified as Li Jun. The welding variables recorded by QC appeared to comply with the WPS – B – T – 3213 – B – U2a – 1. (See attached photo)
